COPPER INDUCED CRACKING OF A TYPE 316L
STAINLESS STEEL CIRCUMFERENTIAL BUTT WELD

SUMMARY:

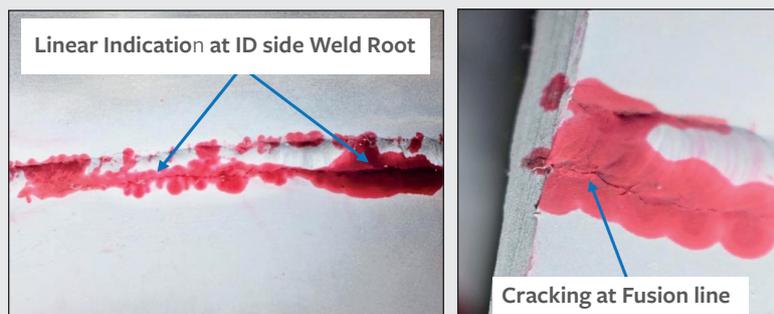
Pipe section received in the lab was sectioned into two halves and a dye penetrant test was conducted at the outer diameter (OD) and inner diameter (ID) to locate the defective areas. After penetrant test, multiple linear indications were observed at both weld toes and in heat affected zone (HAZ). More than half section of the pipe was found to be defective. Closer views of the inner diameter side defect locations revealed cracking in the weld and the HAZ.

Figure 1(a): Penetrant test at ID side revealed half section of the pipe to be cracked. Cracking was observed in the weld and HAZ / fusion line.

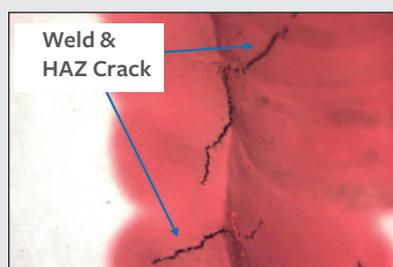
Figure 1(b): Low magnification stereomicroscope images revealed cracking in the weld and HAZ

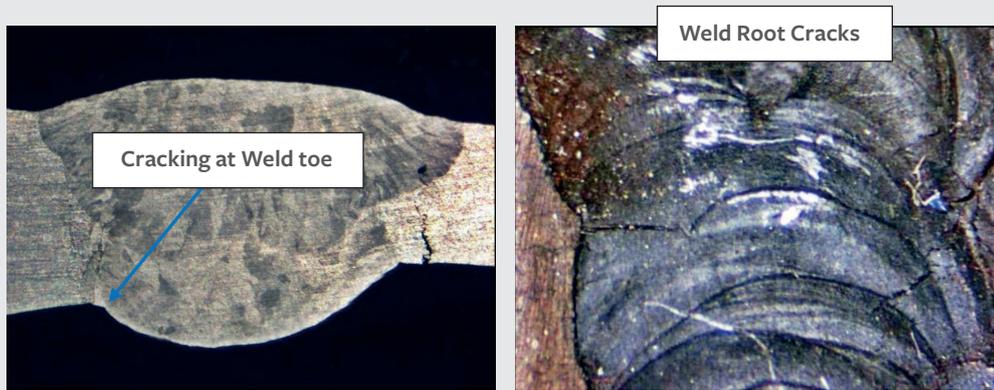
To observe the cross section of the cracked locations, a sample was removed from the cracked area, transverse to the weld, for metallurgical assessment. The macro analysis revealed cracking at the weld toe which was found to subsequently propagate through the weld. A further crack, in the heat affected zone was also observed found propagating through the HAZ towards the pipe outer diameter side. Low magnification stereomicroscope analysis revealed HAZ cracks to be transverse to the weld. Fusion line cracks were found to be oriented parallel to the weld.

Figure 2: Macrographs of the cross-sectional sample revealed cracks in weld and HAZ

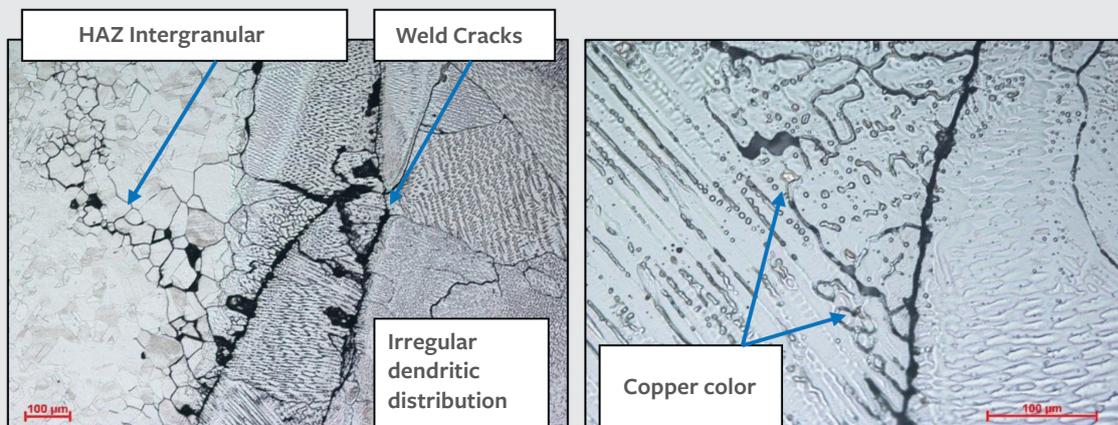
Microstructure of the weld was found to be fully austenitic, confirming an austenitic mode of solidification. Delta Ferrite was found to be mostly absent in the cracked weld regions. The solidification structure of the welds was found to be of mixed mode which was cellular dendritic and columnar. The cracks observed in the weld were predominantly located along the solidification grain boundaries separating a group of dendrites of one orientation from the other. Intergranular cracking was observed in the heat affected zone. No signs of sensitization of the austenite grain boundaries was observed in the section taken. In the weld and heat affected zone, copper colour regions were observed both within the crack and along the dendrite boundaries indicating possible copper contamination of the weld.

Figure 3: Photomicrographs shows cracking in the weld, HAZ and base metal. Copper colour regions were observed along the dendrite boundaries

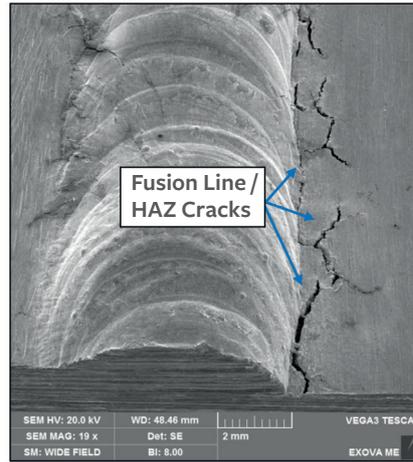
Figure 4: SEM analysis of weld root revealed cracking in the weld and the HAZ

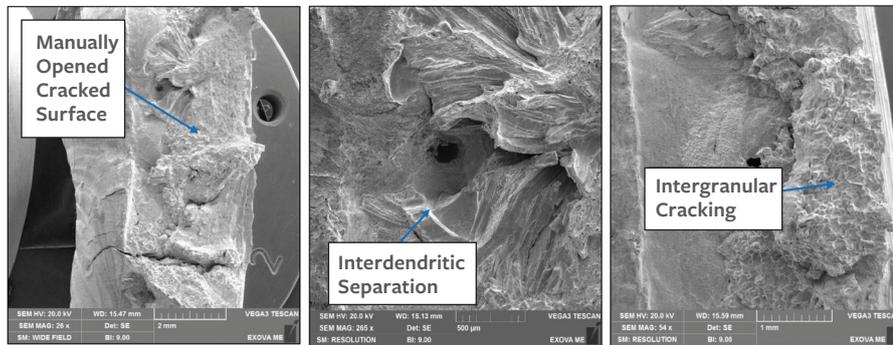
Part of the cracked weld was mechanically opened to analyse the cracked surface at high magnification using Scanning electron microscope (SEM). The exposed surface revealed cracking in the weld deposit to generally follow an interdendritic separation pattern and the heat affected zone cracking shows a ‘rock candy’ type of structure which is a typical feature of intergranular cracking. SEM confirms intergranular cracking of weld and HAZ which was also observed during microstructural examination.

Figure 5: SEM analysis of mechanically opened cracked surface revealed interdendritic separation in the weld and intergranular cracking in the HAZ

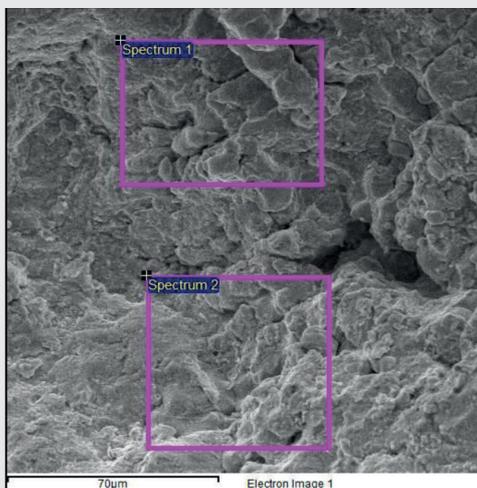
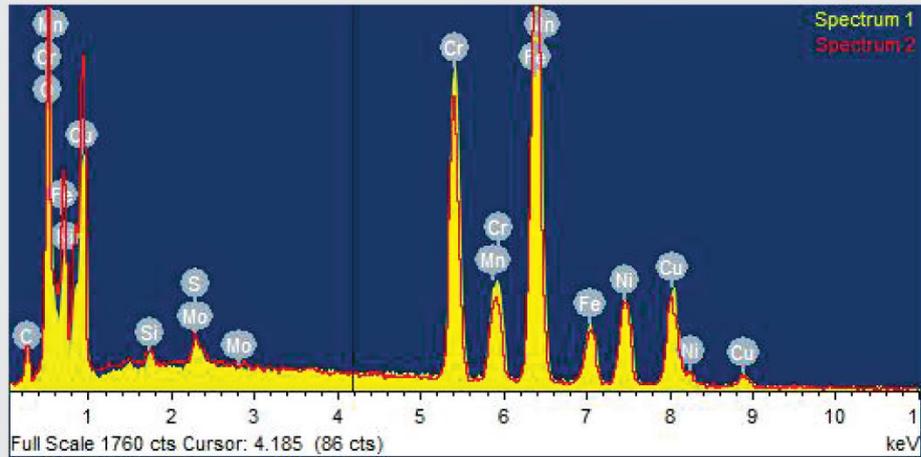
EDS analysis of the cracked surface revealed the presence of iron (Fe), chromium (Cr) and oxygen (O), indicating stainless steel oxidation products. Other stainless steel alloying elements, nickel (Ni) and silicon (Si), are also present. EDS spectra further revealed the presence of significant amounts of copper on the cracked surface which confirmed the contamination present within the weld during solidification.

Figure 5: EDS spectra revealed the presence of high amount of copper on the cracked surface
