## MICROSTRUCTURE ANALYSIS

## MICROSTRUCTURE EXAMINATION OF FOUR CROSS-SECTIONS OF STAINLESS STEEL TUBES

This case study involves four transverse cross-sections of AISI 430 stainless steel tubes having a wall thickness of 0.031" and an outside diameter (OD) of 0.312".

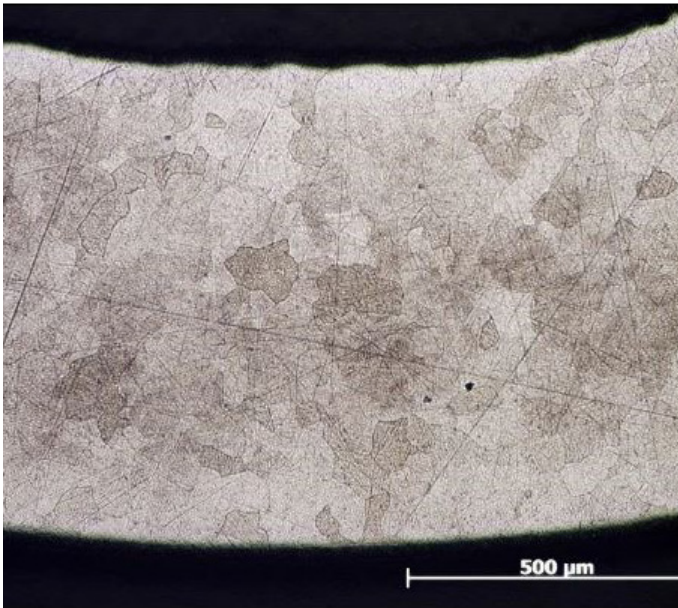
Photograph 1: low magnification of sample 1

The microstructural examination started out with a low magnification of the four samples at 100X. Photographs 1 to 4 are a low magnification view of the transverse cross-section of the tube wall as seen in the etched condition.

All four photographs show ferrite grains with a grain size of 3 per ASTM E112. Samples 2 and 3 also show a network of tempered martensite along the ferrite grain boundaries and on the OD surface of the tube.

Samples 1 and 4 have a microstructure that consists of a dispersion of fine carbide particles in a matrix of ferrite grains.

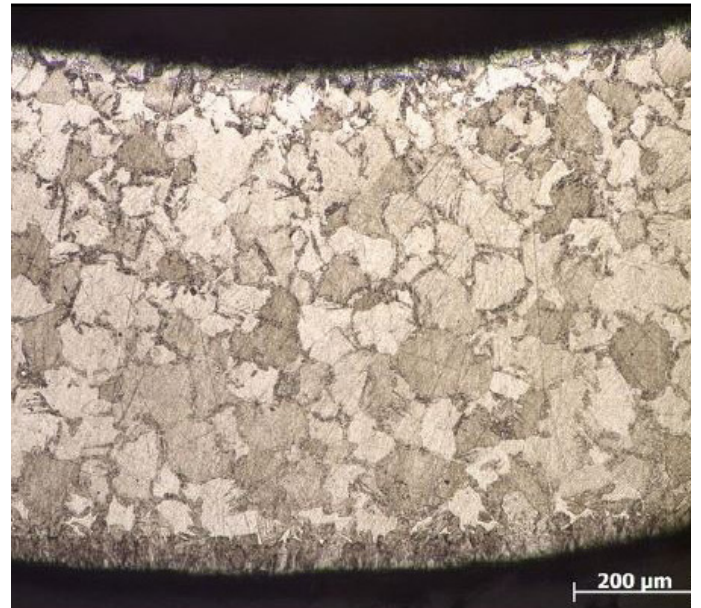
Photograph 2: low magnification of sample 2

The microstructure in samples 2 and 3 shows the presence of a network of tempered martensite around the ferrite grains and at the tube OD surface.

The difference in microstructure explains why some tubes, specifically 2 and 3, cracked during forming.

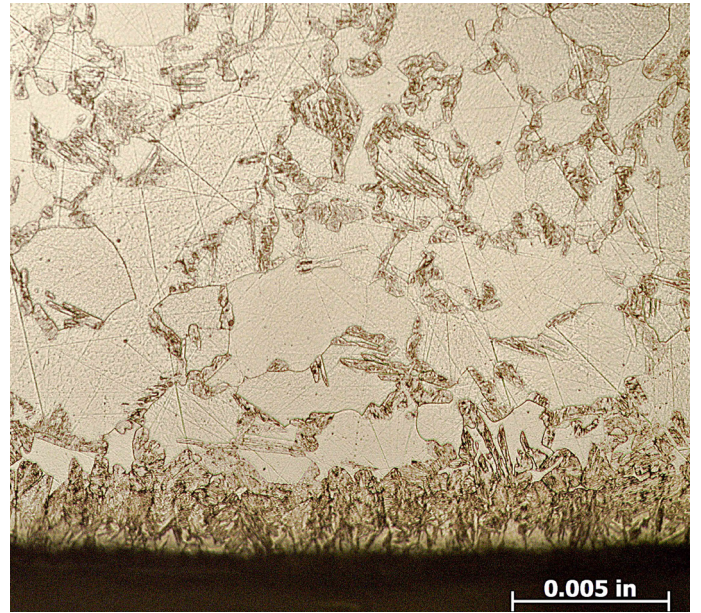
Photograph 6: intermediate magnification of sample 2

focusing in on the tempered martensite exhibited on samples 2 and 3.

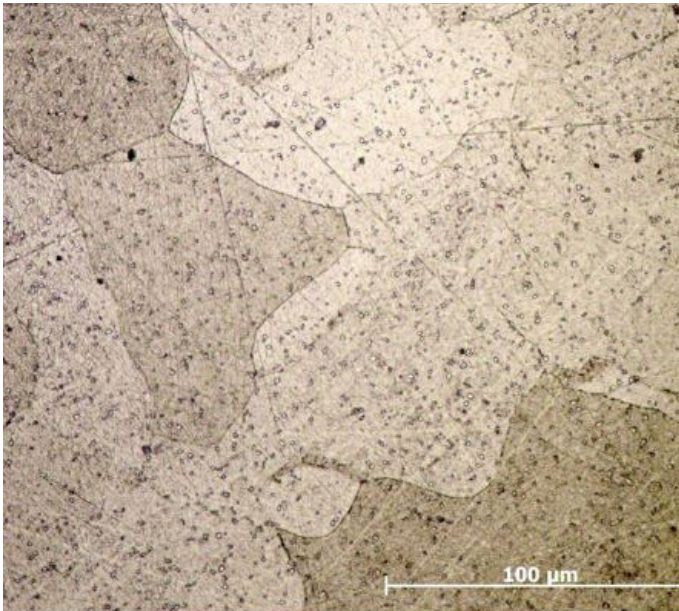
Photograph 9: high magnification of sample 1

Examining the samples at a higher magnification confirmed the presence of white ferrite grains on all samples, and a network of tempered martensite along the ferrite grain boundaries on samples 2 and 3.
